The Columbia Accident

Ballistic Research Supporting the Accident Investigation

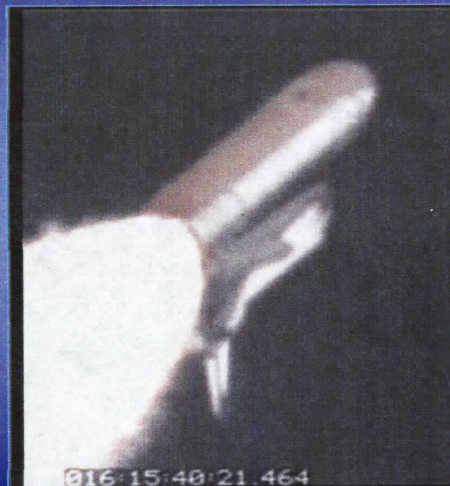
On January 16 2003, Columbia's leading edge was impacted by a piece of foam suspected to have separated from the external tank bipod ramp at 81 seconds into its launch.

Columbia was traveling at Mach 2.46, at an altitude of 65,860 feet. The foam was calculated to have hit the Orbiter at 700 – 800 feet per second

Insulating Foam Separates from Bipod Ramp and Impacts Left Wing of Columbia

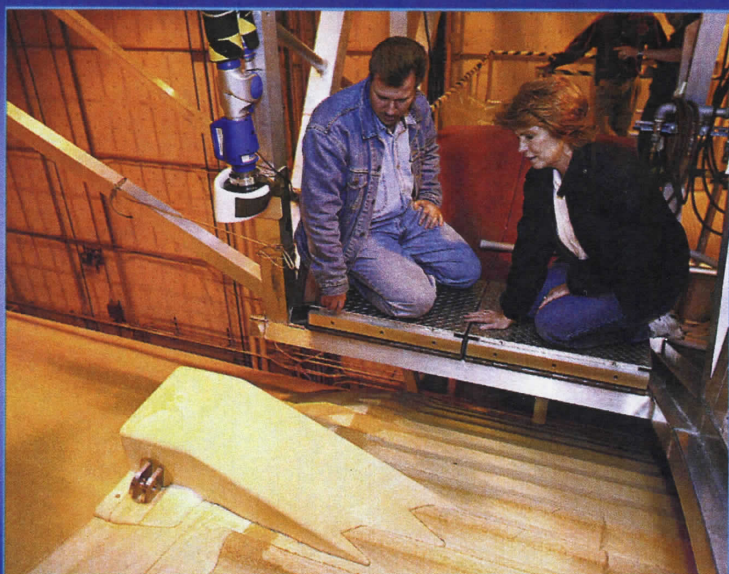
The Bipod Ramp

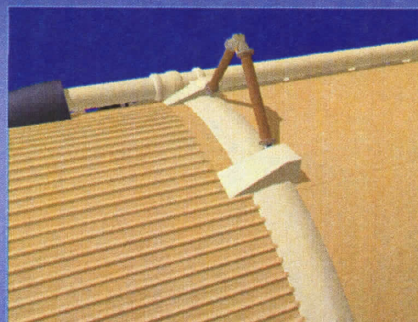
Old Design

Redesign of the External Tank Bipod Ramp

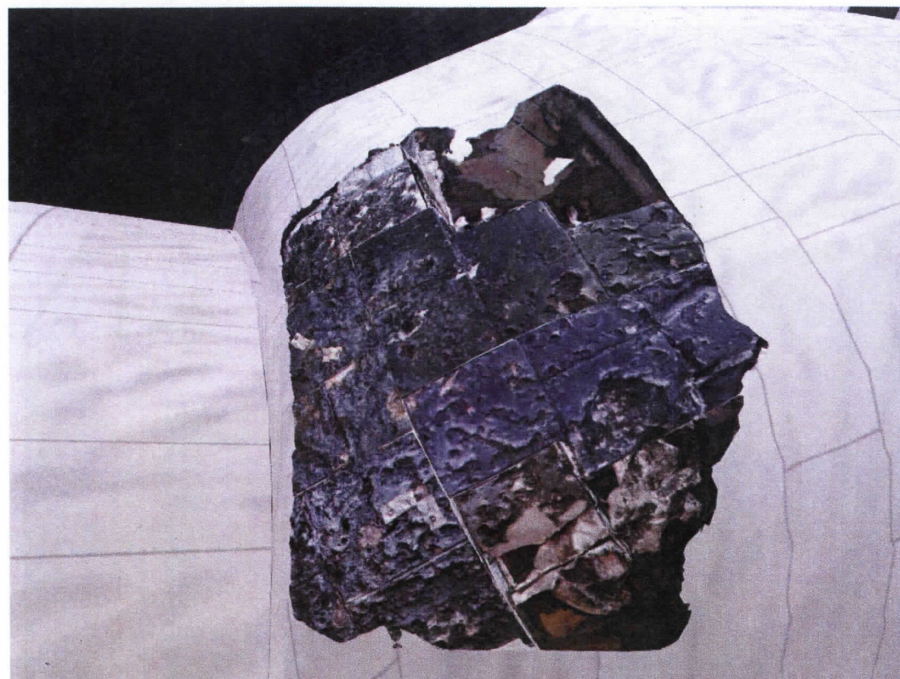
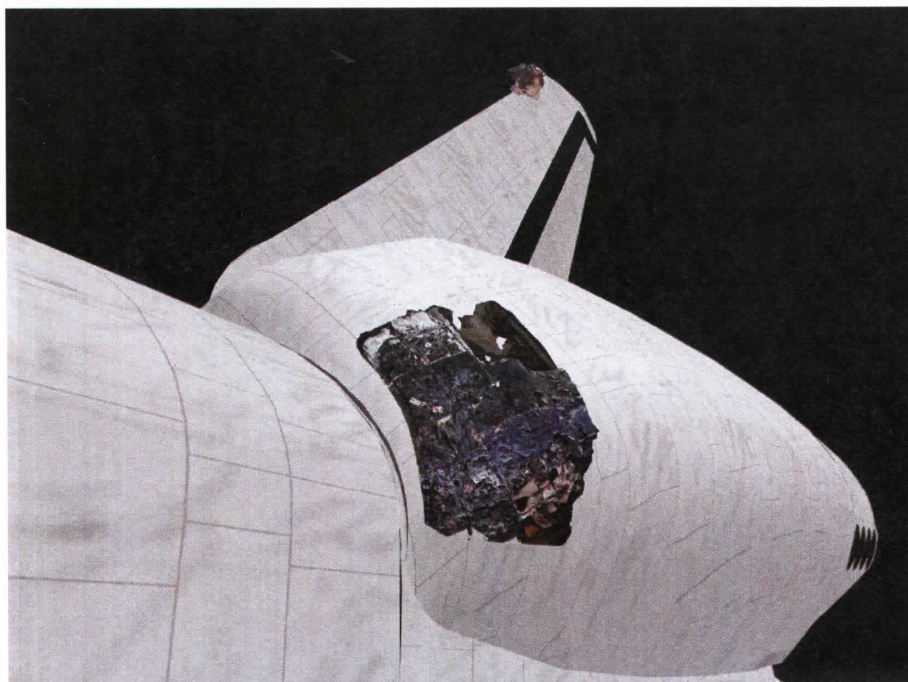
Exiting debris impact OMS
Pod and Tail Section

Carrier panel erosion &
Slumping displayed
evidence of hot gas exit
pathways

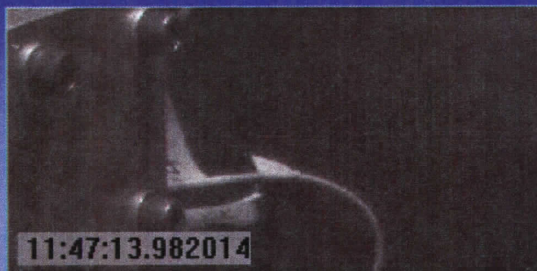
No Vacuum
708 ft/sec

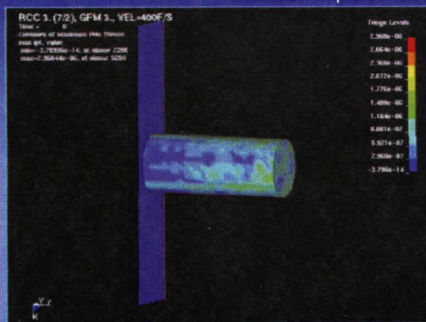
400 ft/second Impact

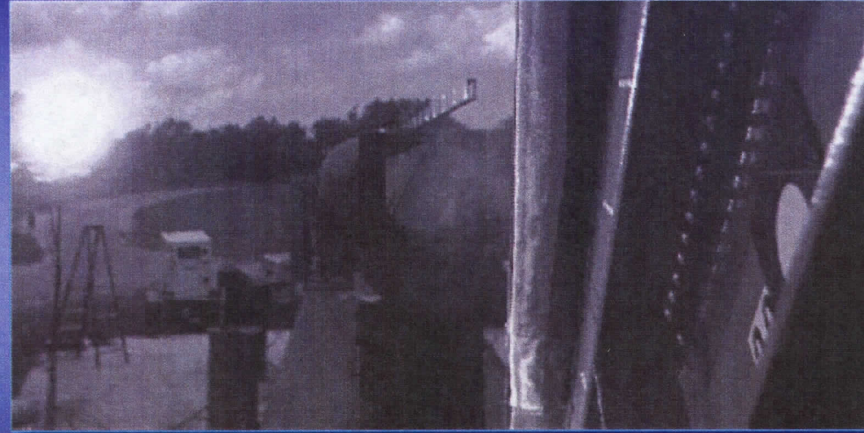
Barrel View of RCC Panel 8 Test

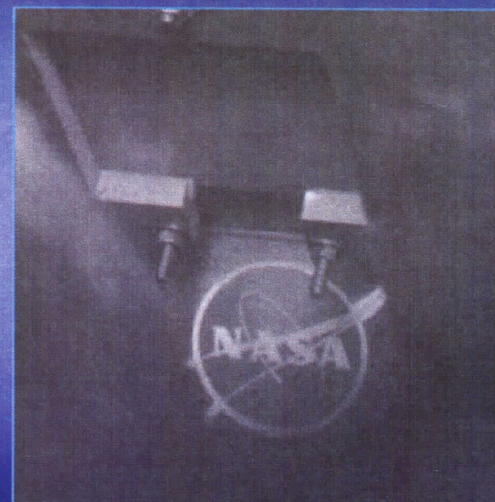
Tile Gap Filler Material Impact Testing
45 degree 604 feet per second

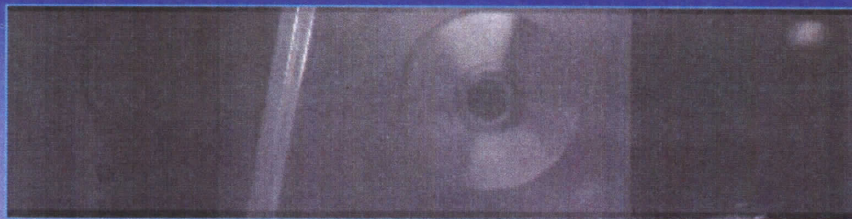
Rear View

NCFI Foam Impact Test on Orbiter Window

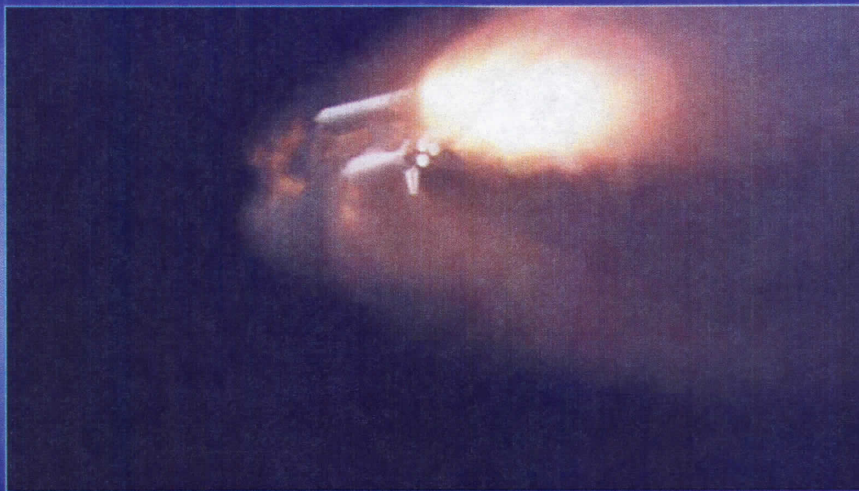
Particulates from Booster Separation Motors a Concern with Windows

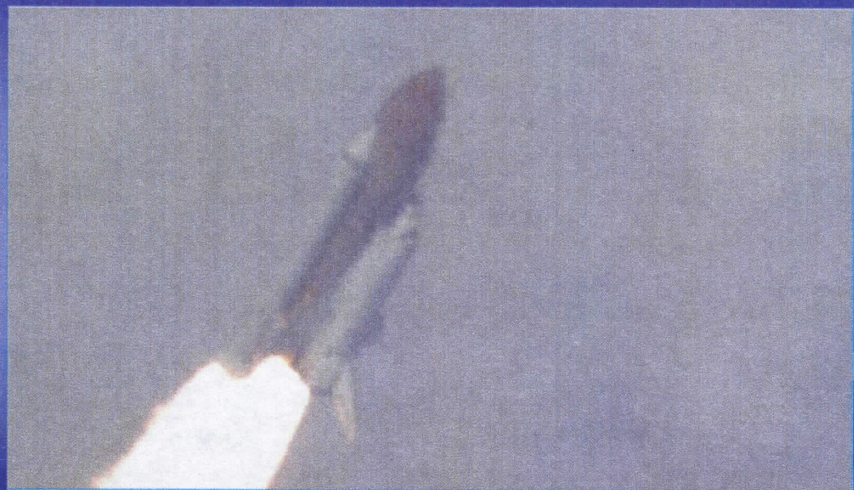
Chase Plane Video of STS-114 Launch

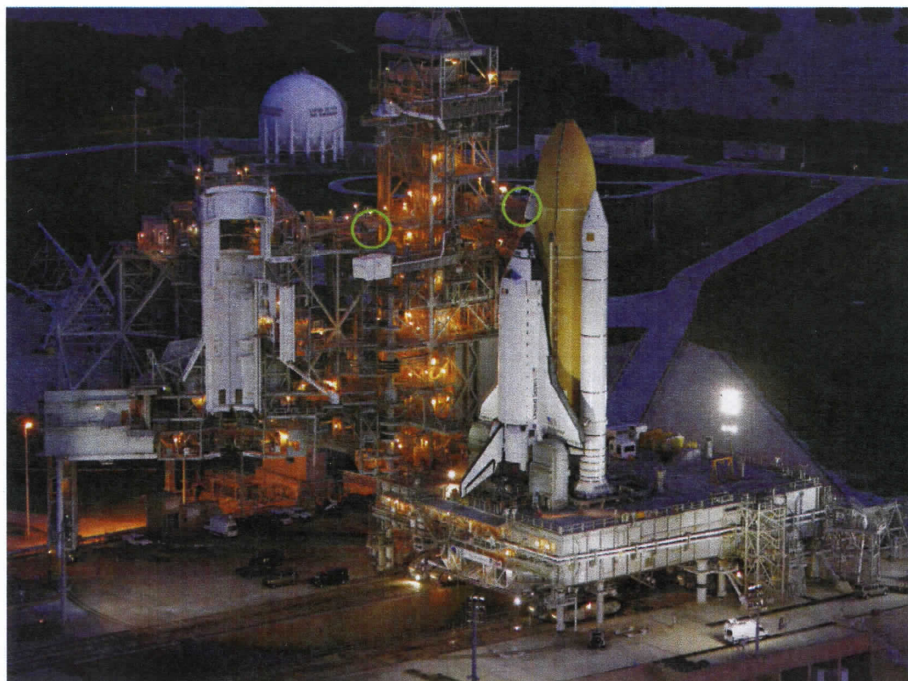
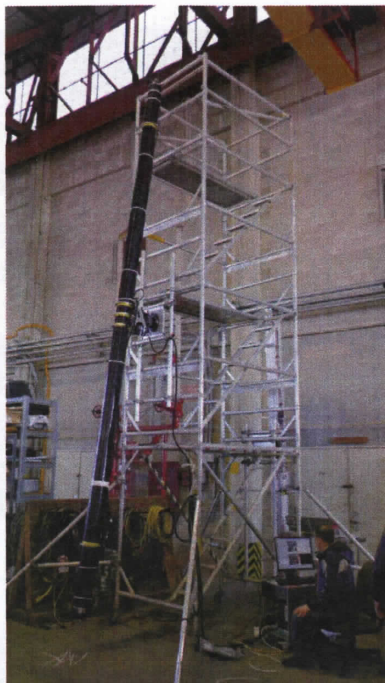
Repair on damaged foam will be first area of interest to be imaged during tanking with the Aramis system.
